## Environmental and Land Management Report Copping Tip

### Winter 2020 to Autumn 2021

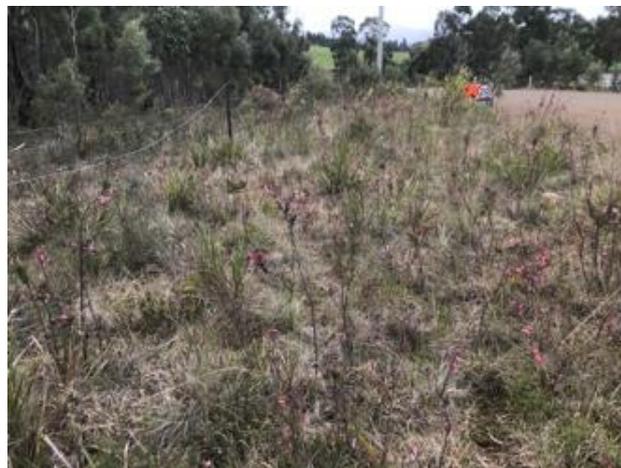
**1.1.3. Spanish Heath** has populated the main road to the Copping Tip for many years. For unknown reasons the spread and overall numbers of the weed had a spike in recent years, however extensive management has led to a decrease in numbers and distribution. Extensive work was carried out again over the past twelve months. following up from previous control work and addressing newly germinated plants.

Photo showing flowering native heath (*Epacris impressa*) road side in late spring post Spanish heath management in winter.

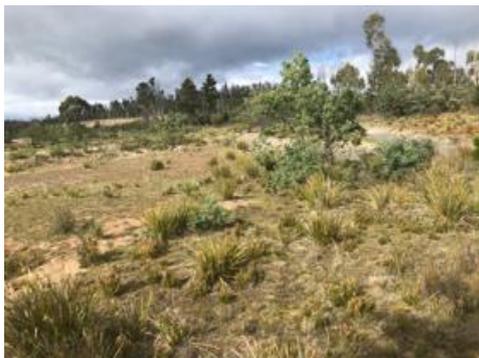
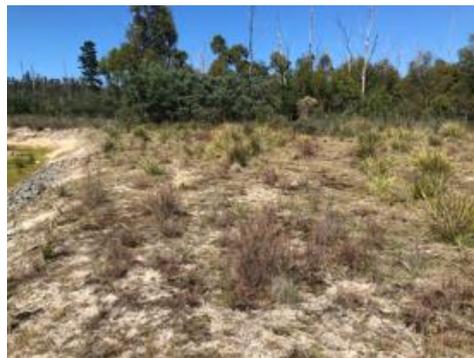
**1.1.6. Spanish Heath** was identified populating a large stretch of land North-West of the landfill site surrounding the settlement ponds. This area has been sparsely populated by Spanish heath in the past and outlier plants were controlled annually. This population however has sprung up rapidly, wide spread at high density across approximately .5 ha. All plants were controlled using a selective woody weed herbicide. This site will require follow up in future years.

Photos showing the new Spanish heath control site prior to and post management

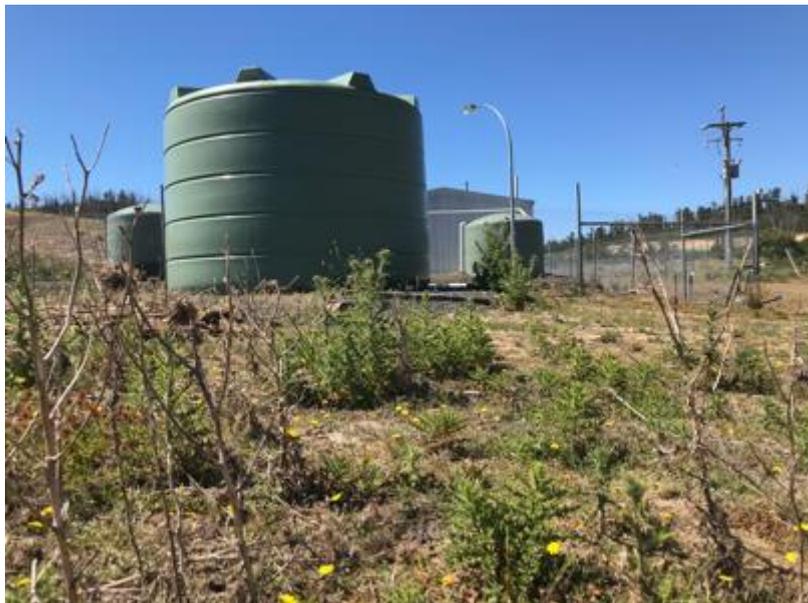
**1.3.1. Californian Thistle** populations are across the property and have been managed at an annual basis over several years. Californian Thistle benefits from disturbance, thus new populations are located most years. The fairly newly discovered road side population was extensively treated in January 2020 and further work was done on it in December 2020, as it is widely spread throughout the old revegetation site. Older known populations were also surveyed and managed, including the population to the North of the landfill site and around the site office. New populations discovered and managed include a population to the North-West of the landfill site near the ponds and a small track side population to the East of the landfill site.

Photo showing Californian thistle populating a track side near the water settle ponds prior to management.

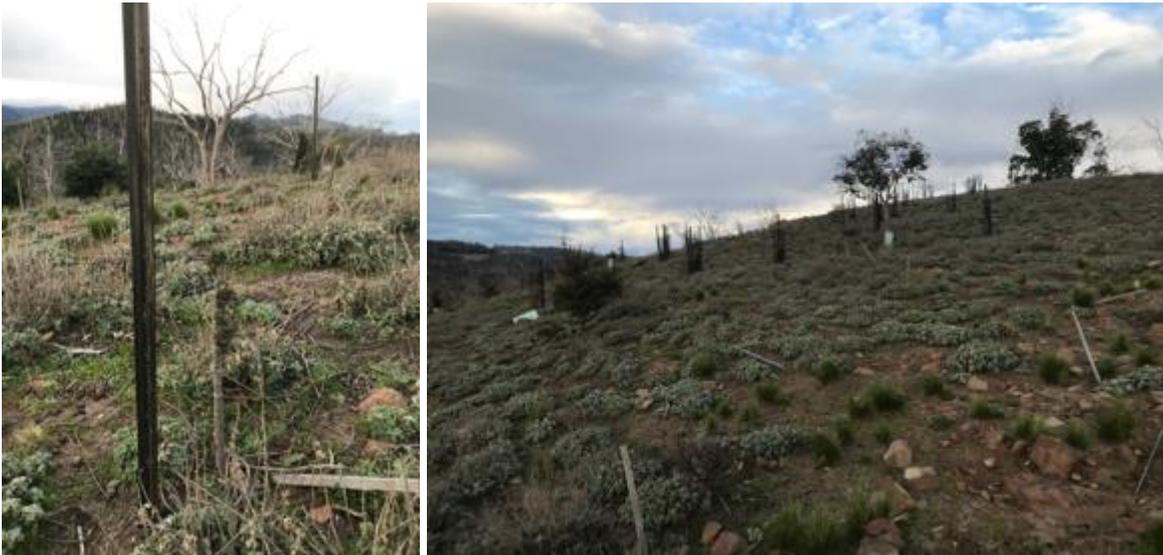
During the 2019/20 management period a trial was carried out establishing the most economic and successful way of guarding trees and shrubs that were planted years ago, however not thriving or putting on any growth due to heavy browsing by wildlife, including deer, as well as sheep.

The trial was successful and all guards proved to be successful and plants developed from being heavily grazed and highly stunted to have filled out the guard entirely over nine months.

Photo showing a heavily browsed Casurina (*Allocasurina verticilata*) prior to guarding and established guards around trees and shrubs across the hill.

Based on these observations, guards were fitted to all trees and shrubs planted across the hill over the past years, providing long term competition to serrated tussock.

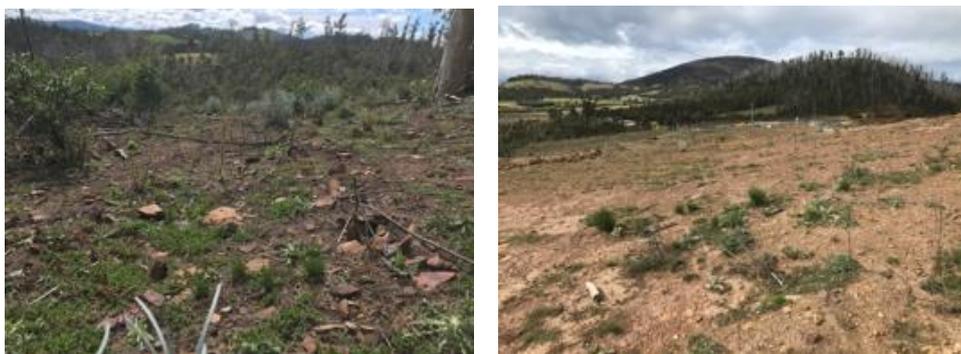
**1.4.3. Serrated tussock** has been populating the area North of the main landfill site. Ongoing disturbance of this site as part of the tip expansion has reduced the numbers, however has also led to the spreading of the population across larger area. In the winter of 2020/21 widespread chipping and spot application of Flupropanate targeting patches of more than five individuals was carried out.

Photo showing serrated tussock seedlings germinated in open disturbed ground

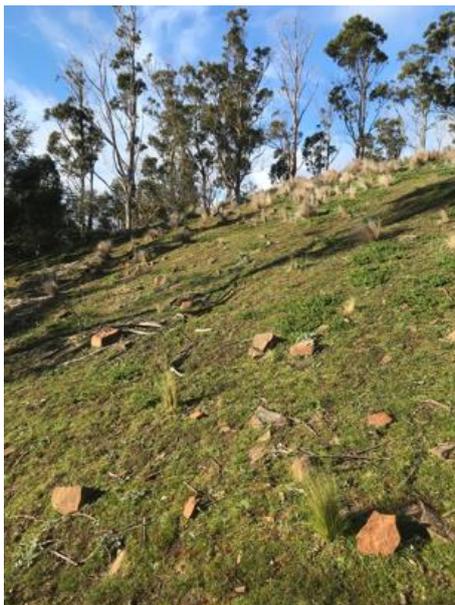
**1.4.5. Serrated Tussock** was found populating a small exposed hill top North of the landfill site during the 2018 survey, close to the property boundary. There were several outliers nearby along the fire trail. All sites were controlled during 2019/20 with high success rates. Follow up work applying Flupropanate was carried out in winter 2020 and 500 native tussocks (*Poa labillardierei*) were planted providing competition to germinating serrated tussock seedlings and long-term ecological health.

Photo showing serrated tussock seedlings germinated after primary control in winter 2019

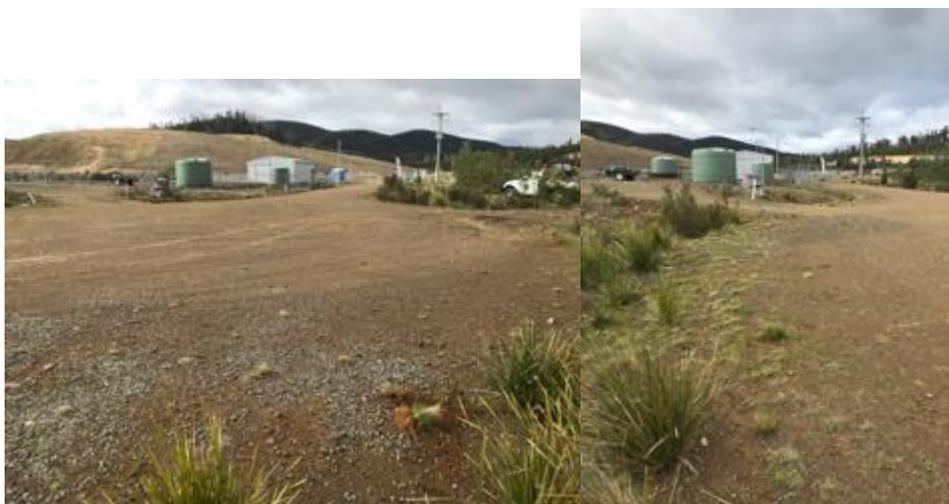
**1.4.6. Serrated Tussock** was located next to the track near the water ponds and managed.

Photo showing serrated tussock seedlings on the side of a track near the water settlement ponds

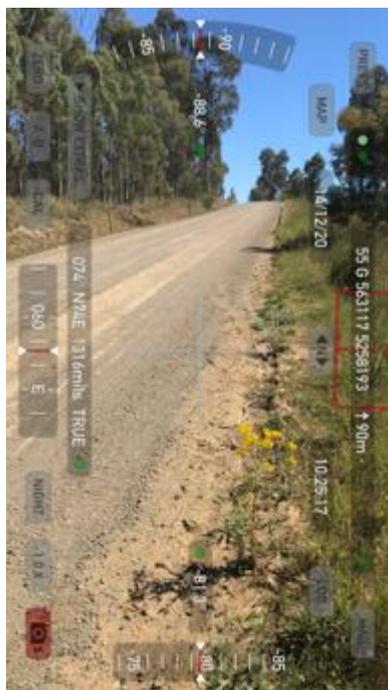
**1.5.1. Ragwort** has not posed an issue in past years, however in December 2020 some road side plants were located and controlled. These plants may be associated with increased farming activity within the area or road works. Regardless, Ragwort will be on the alert list in future years.

Photo showing road side Ragwort including GPS data

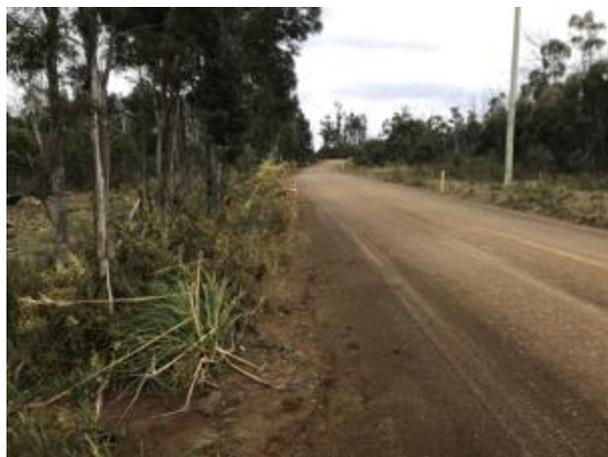
**1.6.1. Pampas** has been an issue across the property historically, however all known populations had been eradicated several years ago. In spring 2020 however two young road side plants were located and controlled.

Photo showing road side pampas

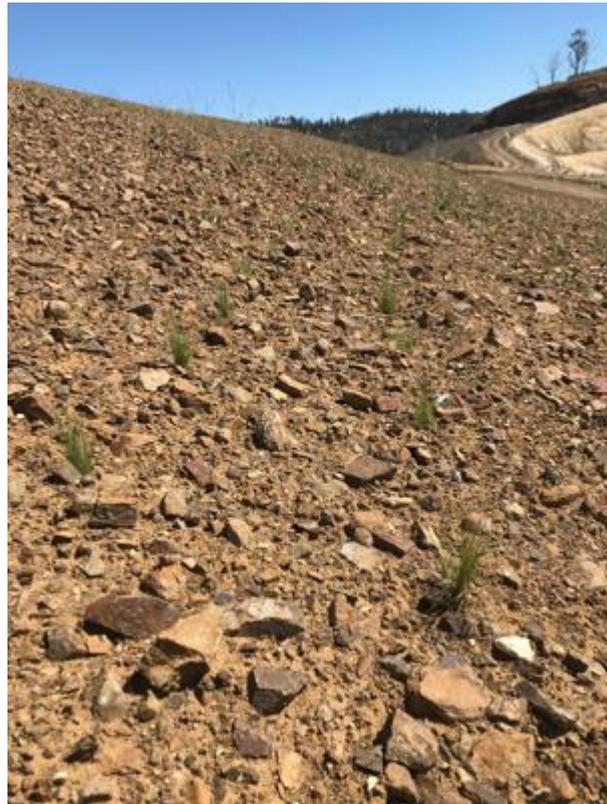
In early spring 2020 a large area across a scree slope forming the boundary of the landfill mound was planted out with 10 000 native tussocks (*Poa labillardierei*). The ground is heavy clay and in some parts the depth of gravel and rocks forming the scree was too deep to plant into, however a high success rate will lead to the native tussocks forming a good cover across the site in coming years and self-seeding will extend this population further.

Photo showing young planted native tussocks across the landfill mound
