# Land and Environmental Weed Management at the Copping Landfill Site Winter 2018

### **Environmental Weeds Management, May to August 2018**

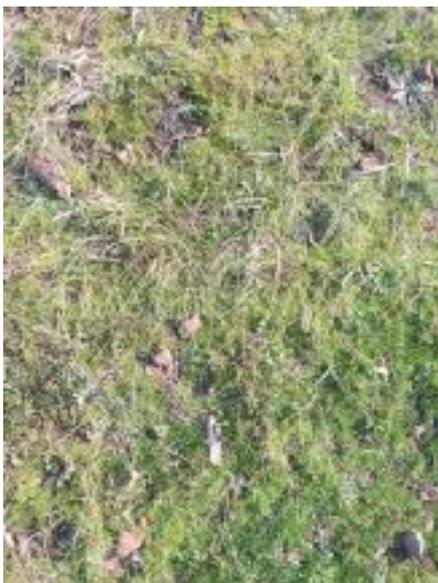
Dense rye grass ground cover

Areas around the landfill site have been subject to development, involving earth works and minor clearing of vegetation. Bare ground provides an ideal environment for Serrated Tussock. The area subject to the recent land development is known to be populated by a managed Serrated Tussock population. A pro-active response of establishing a competing cover crop of Rye Corn, Rye Grass and native tussock (*Poa labillardierei*) followed by fertiliser and lime, established well, providing a ground cover. Early Serrated Tussock seedlings were outcompeted and establishment of plants limited.

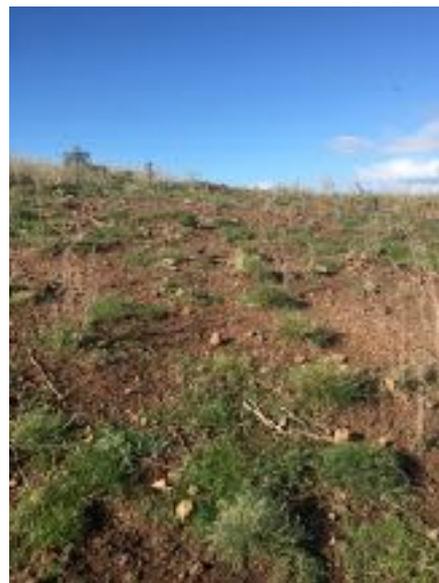
Well established native tussock  
(*Poa labillardierei*)

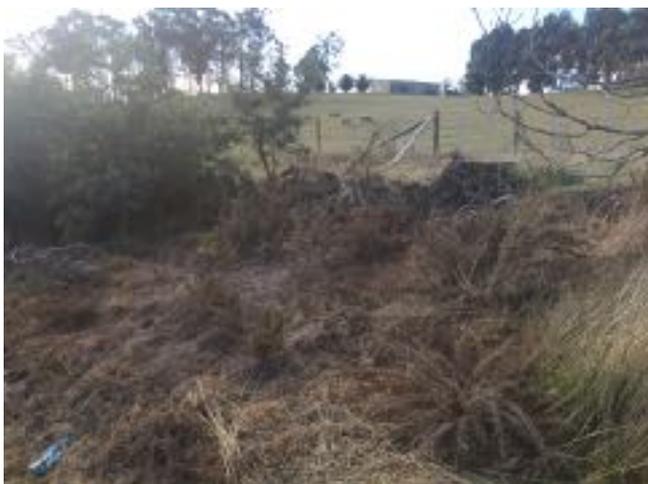
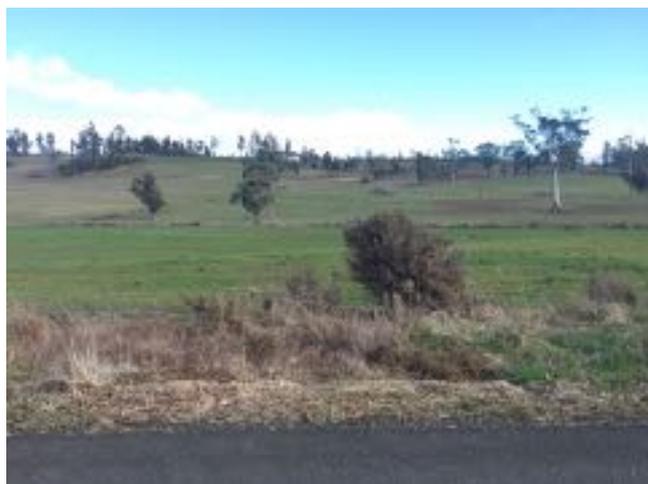
Gorse management along Blue Hills Road. Photo taken two months after foliar application has been carried out. Plants are showing signs of die back.

Gorse has been on the target list since 2010. As in previous years, old populations in and around the back paddock were targeted, treating re-growth from previous management, as well as newly germinated seedlings. Outlier plants were treated along the North-Western boundary track and extensive Gorse control was conducted along Blue Hills Road. The Gorse population along the track to the pack paddock showed no re-growth or new seedlings for the first time in eight years.

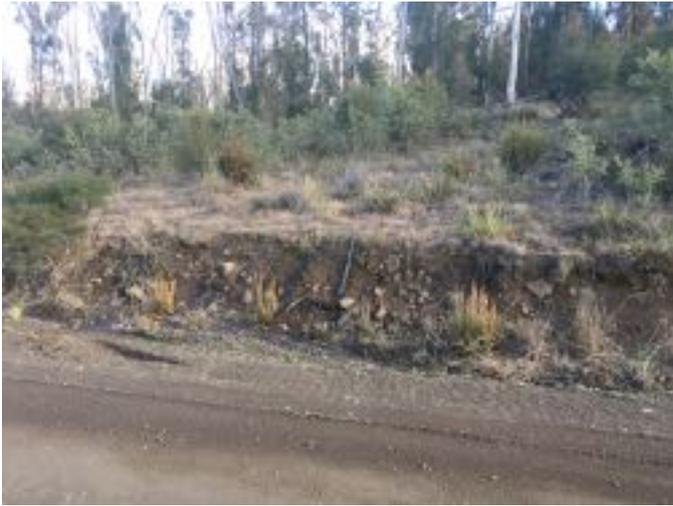
Spanish Heath management along Blue Hills Road.  
Photo taken two months after foliar application.

Several new and old Spanish Heath populations and individual plants have been treated along Blue Hills Road. Distribution has doubled over the past year throughout this area. In previous years extensive control was conducted annually, with very little follow up work carried out in spring. However management may be increased to bi-annual control to minimise the ongoing spread of this aggressive invader.

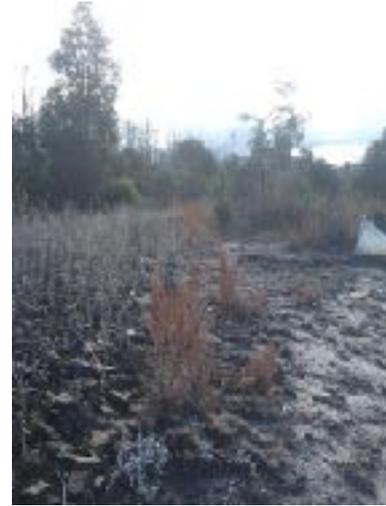
Spanish Heath management South-  
-West of the tip among native  
heath. Photo taken two months after  
foliar application.

A further area of concern, which is subject to notable expansion of Spanish Heath lies to the South-West of the tip. Spanish Heath is among native heath in this area, thus difficult and time consuming to control. Spanish Heath is well established throughout this area with a staggering amount of seedlings. This area has been managed extensively during recent months, however will benefit from follow up work in spring 2018.

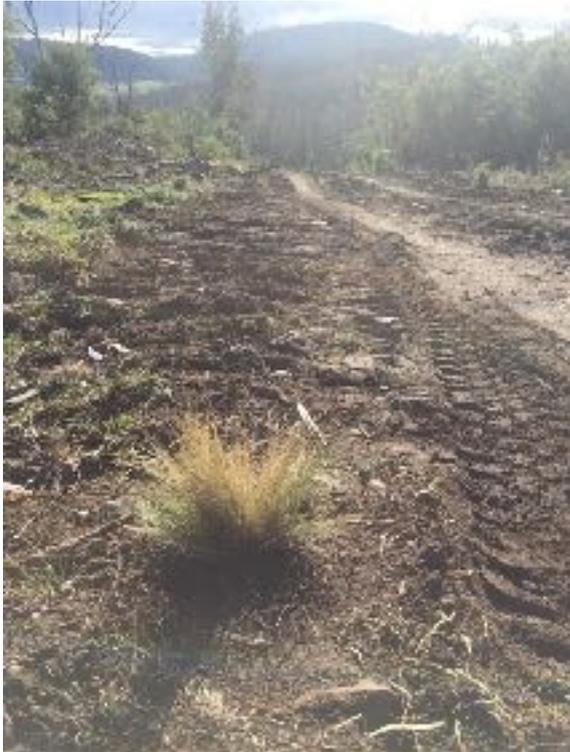
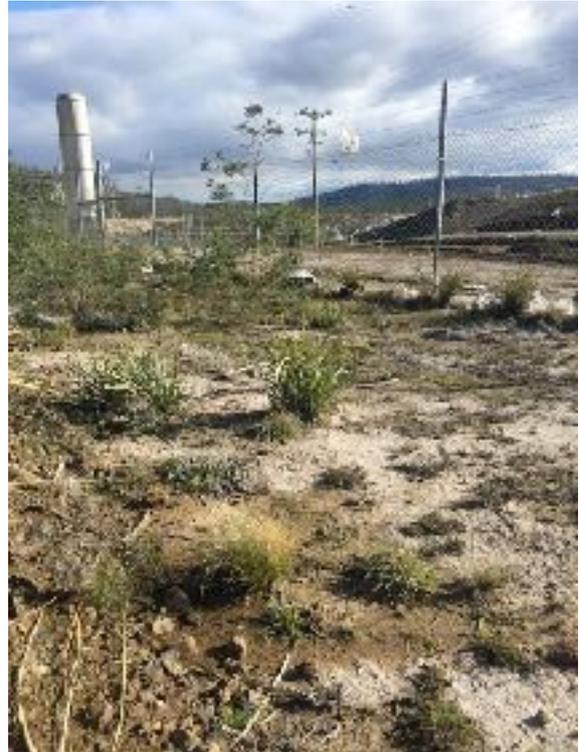
Photo showing outlier Serrated Tussock seedling along track behind site office.

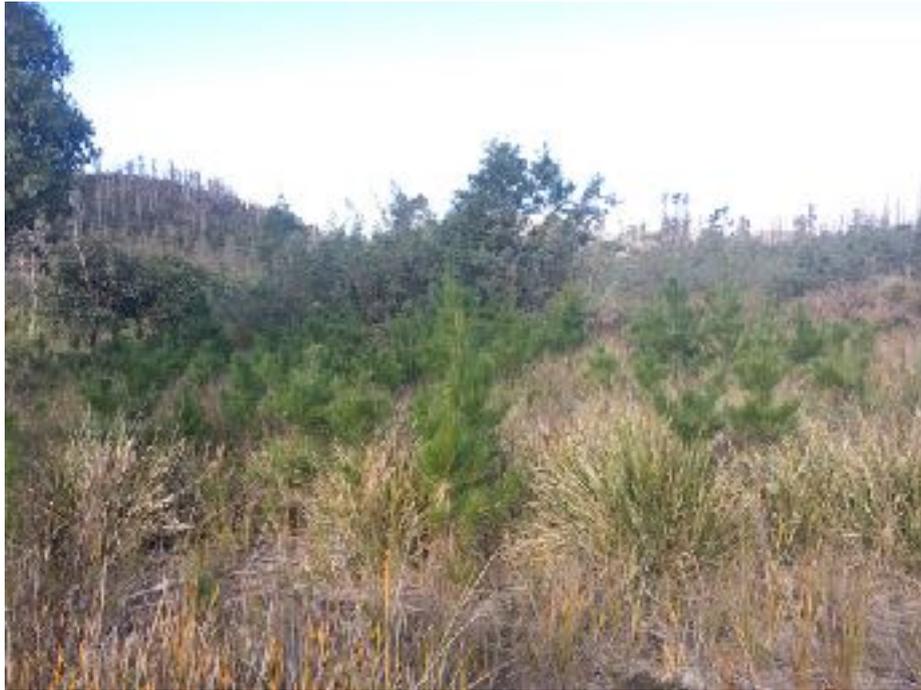
During a survey in early 2017, a rapid invasion of the neighbouring *Pinus radiata* plantation into native bushland at the Copping tip was noted. Saplings were treated in the winter of 2018. Management will be ongoing, as further sites threatened by its invasion are becoming apparent.

*Pinus radiata* becoming established across parts of the property

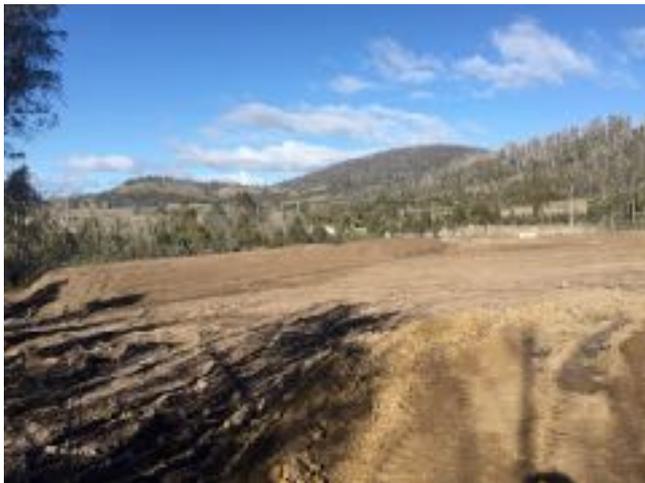
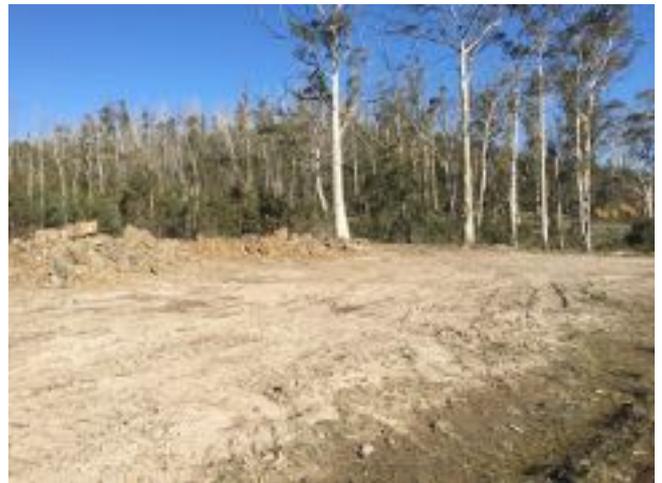
Photos showing areas subject to recent disturbance

In the spring and autumn, establishing of cover crops is recommended in areas subject to recent soil disturbance. In the winter of 2019, ongoing follow up work of known weed populations is recommended, in combination with continuous planting of native grasses.

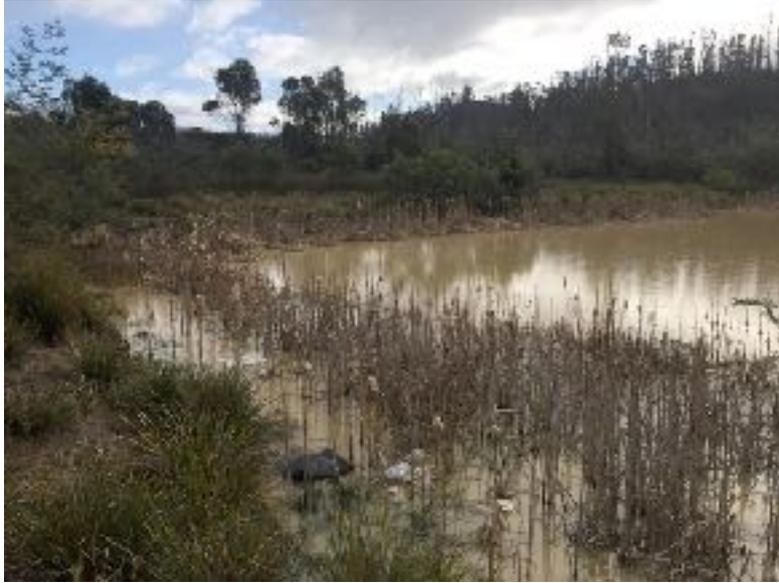
The wetland/ settling ponds at the Copping Tip are subject to Cumbungi invasion. Management of Cumbungi may be considered for spring 2019 or 2020.

Photo showing Cumbungi invasion of settling ponds.
