# **Environmental Management at the Copping Landfill Site Winter/ Spring 2016**

Axel Meiss

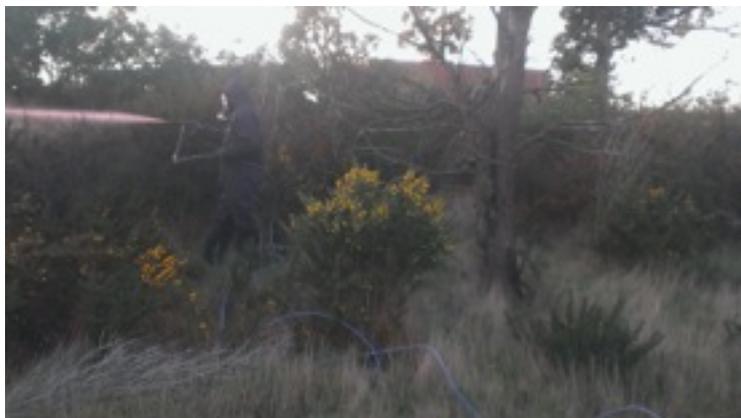
Primary control of a considerable amount of Gorse was conducted along the access road to the landfill site, Blue Hills Road. Gorse has become well established throughout native road site vegetation. Some off-target damage will be expected due to proximity. Extensive follow up work in future years will be necessary.

Photo: Foliar herbicide application of gorse

In the winter of 2017, ongoing follow up work of known weed populations is recommended, in combination with continuous planting of native grasses, shrubs and trees. The access road to the Copping Landfill Site, Blue Hills Road, has had primary control conducted in 2016, requiring extensive follow up and management.

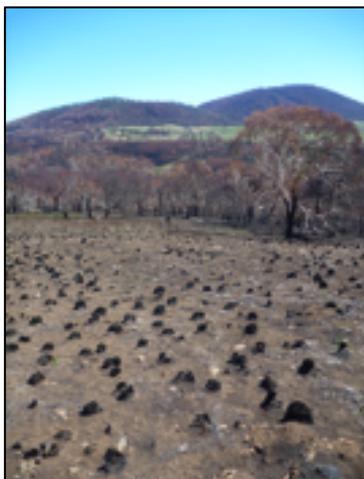
Photo: Main Serrated Tussock site after the bushfire. February 2013

A large Serrated Tussock population has been a prime focus of management. The site is difficult to access. The initial population was a dense monoculture, and stretched over several acres.

Vigilant management and trialling and applying a number of different management techniques have proven to be very successful and the site has changed to a native revegetation site.

Serrated Tussock germination since treatment in 2015 has been limited. However, some areas still had considerable germination of seedlings. Overall, population size and density has decreased remarkably. No mature plants were present at any sites.

Areas that showed considerable germination rates were spot treated with Flupropanate.

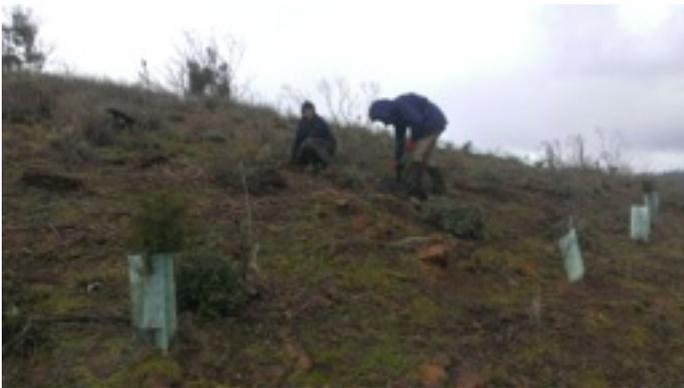
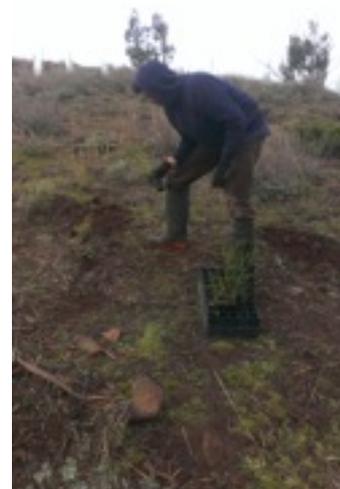
A key management tool has been the establishment of a competitive vegetation cover such as native tussocks (*Poa labillardieri* and *Poa rodwayi*), as well as native trees and shrubs including native wattle species (*Acacia dealbata*, *Acacia verticillata*, *Acacia melanoxylon*), Native Hop Bush (*Dodonaea viscosa*), and Casuarinas (*Allocasuarina verticillata*). More than 7 000 native grasses, trees and shrubs have been planted over the past years.

Photo: Planting of native trees and shrubs

Survival rates of planted trees and shrubs of previous years have been high, however development is stunted due to browsing stock and wildlife. There has been a high rate of establishment amongst the planted native grasses, however development and growth is dictated by annual weather conditions.
